## REPORT OF STRUCTURAL TESTING OF PREMIER CUTTING CHIMNEY SYSTEMS

Premier Cutting supplied Ceram with three types of their pre-fabricated Chimney systems, the Mid Ridge Chimney, the Mono Pitch Chimney and the Gable End Chimney to be subjected to several types of strength tests and soak coat water testing to determine the product's performance.

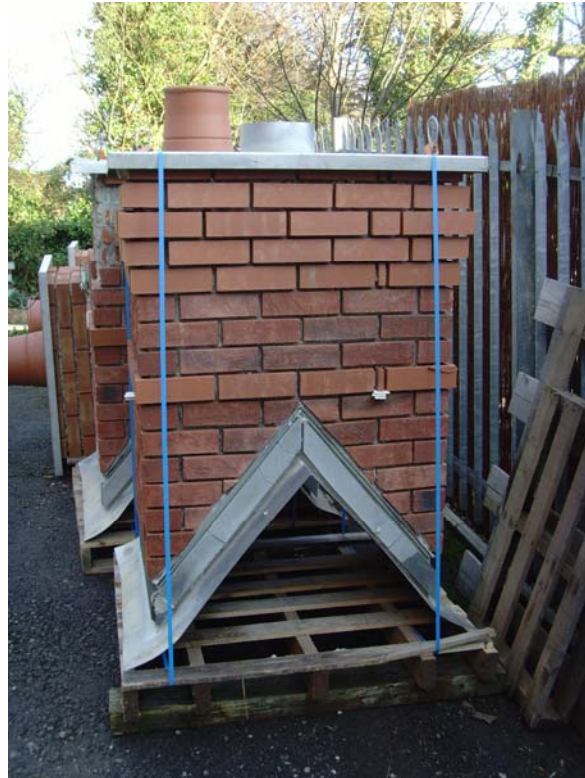
**Plate 1**  
General View of Mid-ridge Chimney

A general view of the mid-ridge chimney is shown in plate 1, likewise the mono-pitch is shown in Plate 2 and the gable end is shown in Plate 3.

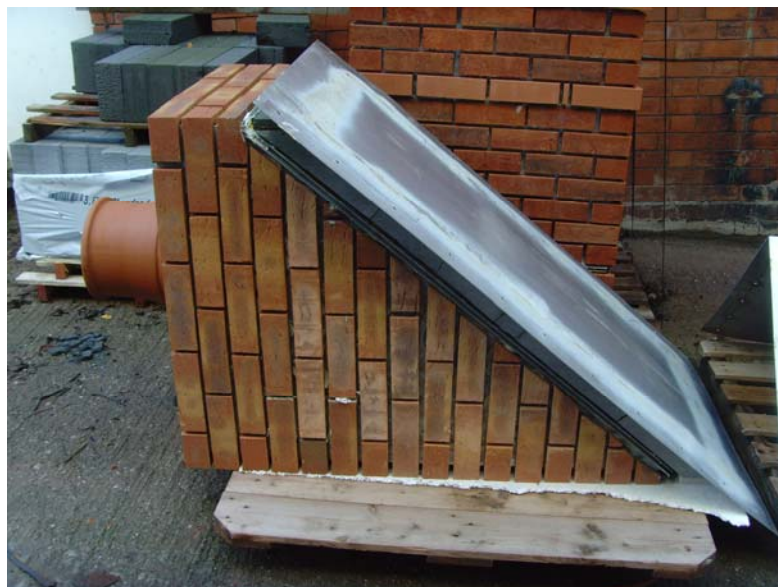
**Plate 2**  
General View of Mono-pitch Chimney

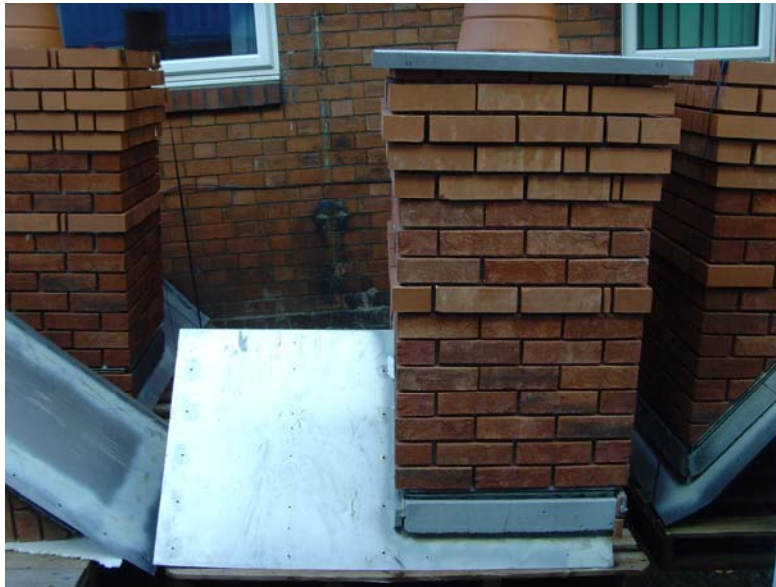
**Plate 3**  
General View of Gable End Chimney

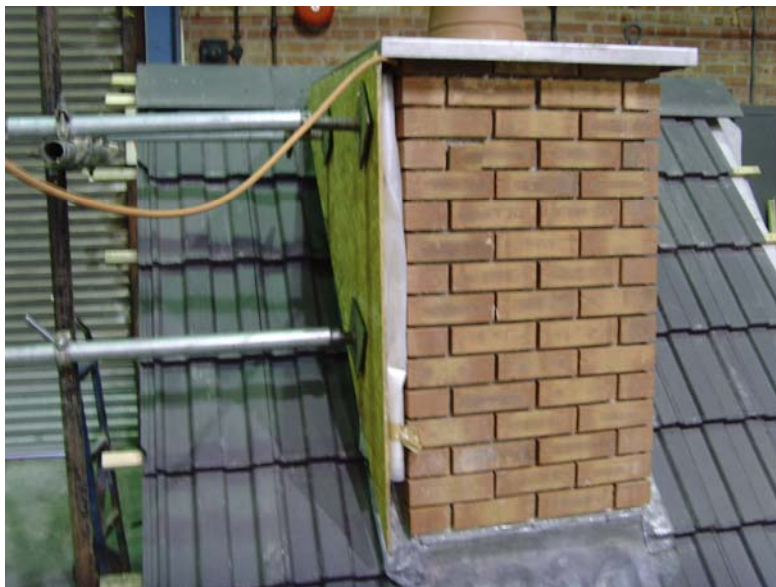
**Plate 4**  
General View of Mono-pitch Chimney under Wind Load

A general view of the Wind Resistance test arrangement can be seen in Plates 4.

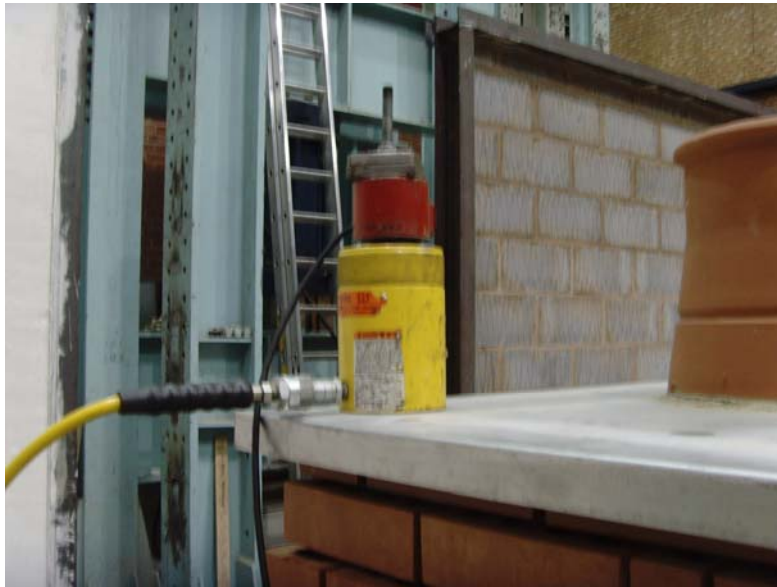
**Plate 5**  
Testing of Lifting Eye

A general view of the Lifting Eye Tensile Strength test arrangement can be seen in Plate 5 and a general view of the failure mode is given in plate 6.

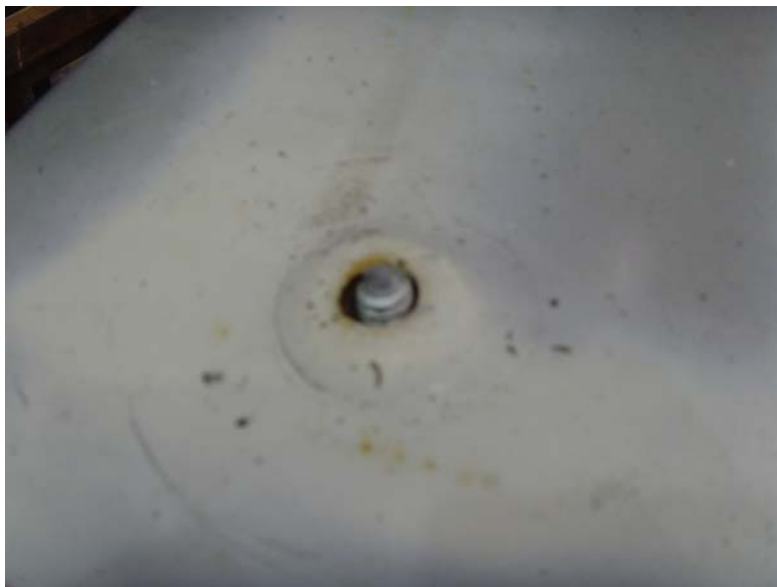
**Plate 6**  
Failure of Lifting Eye

All lifting eyes showed the same mode of failure, where the steel lifting eye rod dislodges and pulls up through the chimney core and crown.

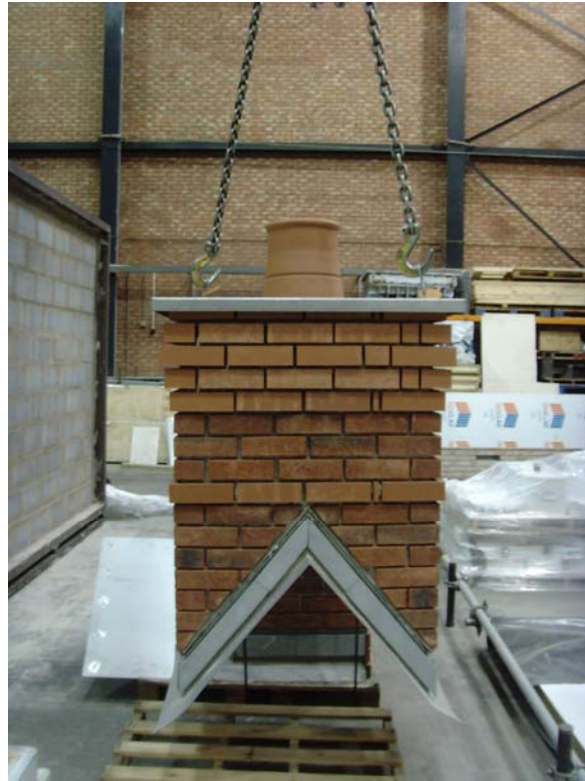
**Plate 7**  
Chimney under Lifting Eye Test

A general view of the Chimney Lift can be seen in Plate 7.

All chimneys were lifted successfully via the appropriate lifting eyes and held for 10 minutes. When lowered, no sign of damage or distress around the lifting eyes was present.

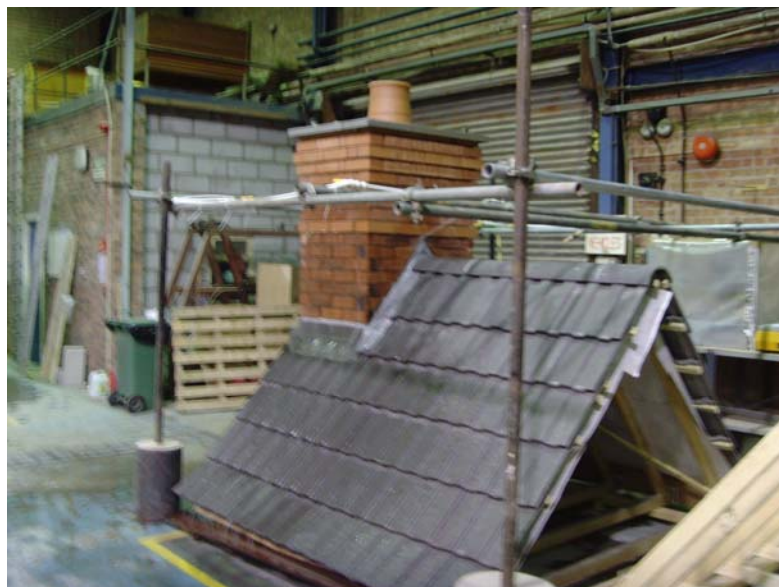
**Plate 8**  
General View of Gable End Chimney under Water Tightness Testing

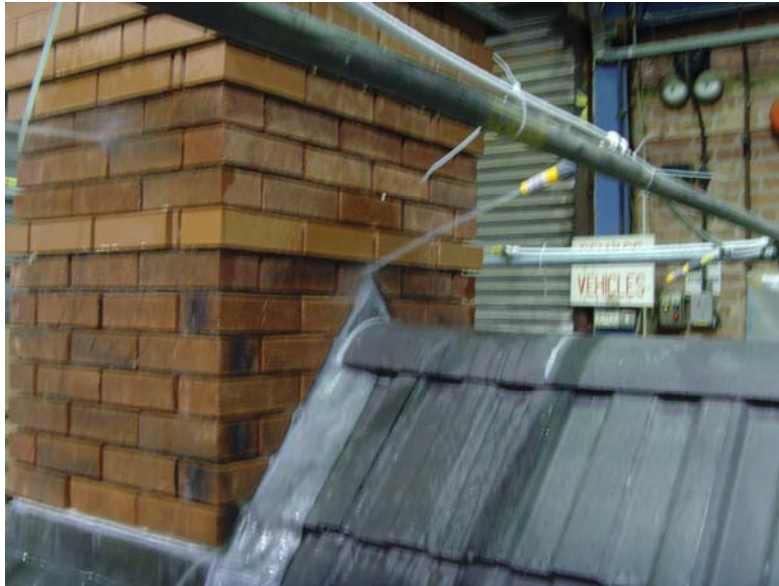
**Plate 9**  
Detailing of Lead Flashing for Gable End Chimney

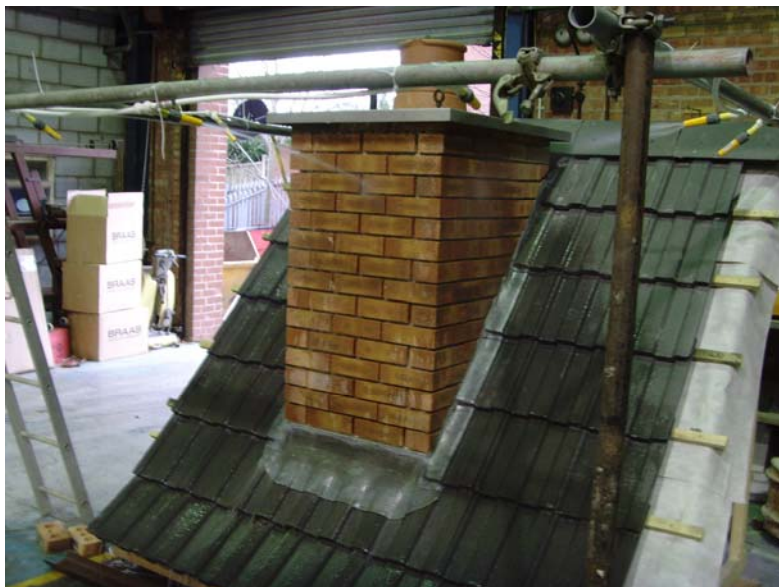
**Plate 10**  
Mon-pitch Chimney under Water Tightness Testing

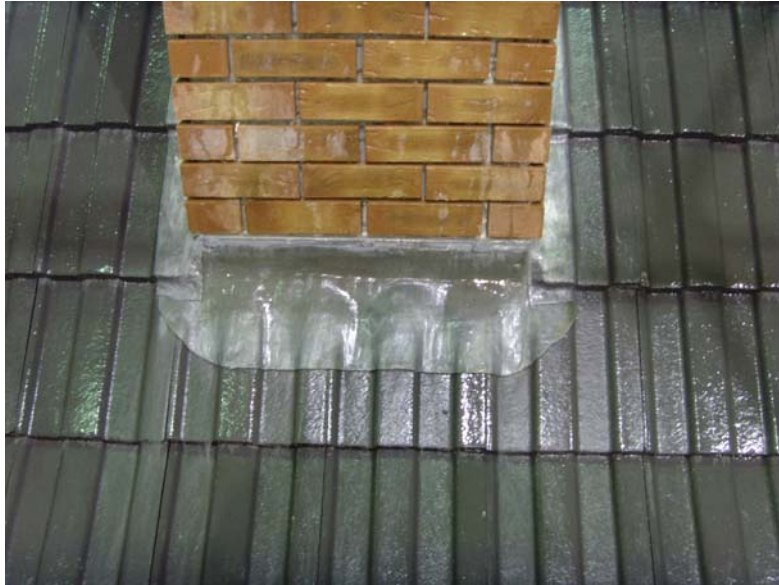
**Plate 11**  
Detailing for Mono-pitch Chimney

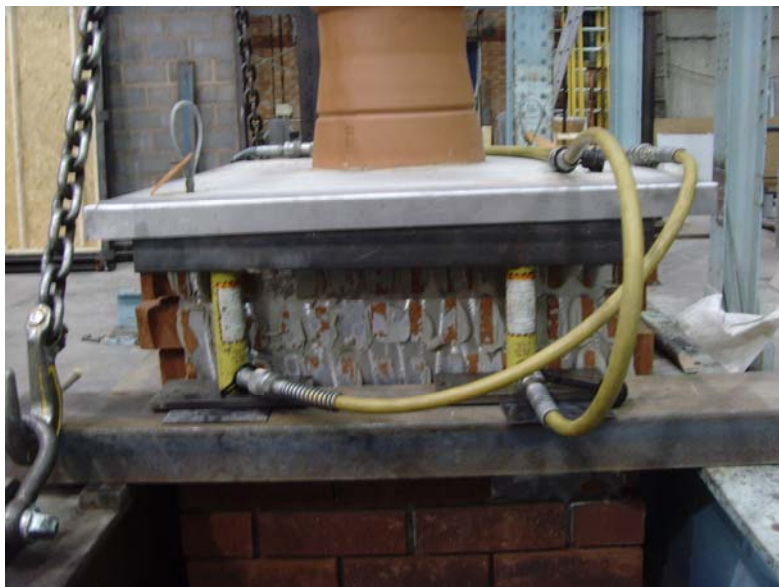
**Plate 12**  
General View of Chimney Crown Pull-off Test

A general view of the chimney crown bond strength test arrangement can be seen in Plate 12 with a view of the failure mode given in Plate 13.

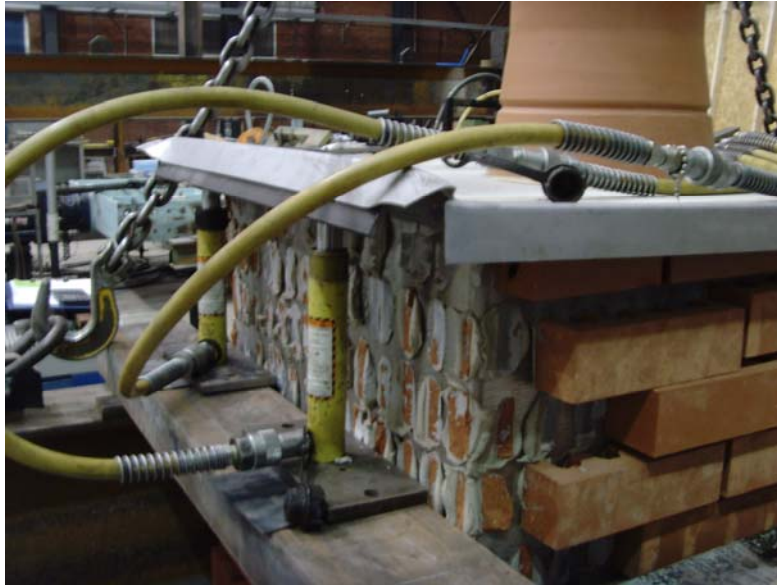
**Plate 13**  
Failure of Crown by Bending of Overhang

The crown did not detach from the chimney body. Mode of failure was bending and deformation of the crown overhang.
